Manhole Inspection Summary

Manhole # S21K1_022MH

Location Address: **3000 marbourne av**

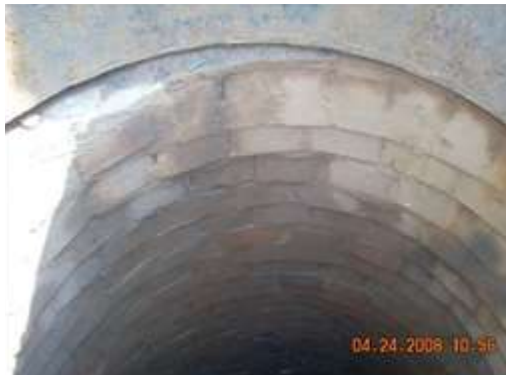
Defect 3

Infiltration: ☐ None ☐ Joint ☐ Cracks ☐ Mortar ☐ Roots ☒ Wall

infiltration @ corbel wall

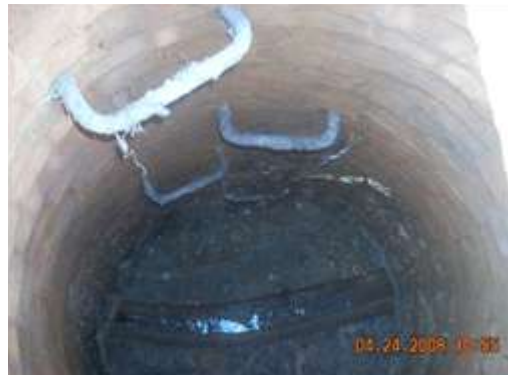
Defect 2

Count: **4** Missing: **0** ☒ Corroded

corroded steps

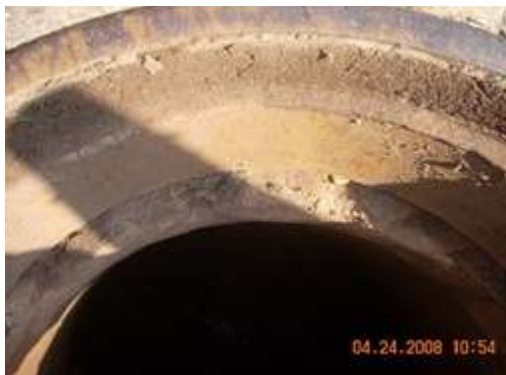
Defect 1

Offset: **1.5** (in.)

frame offset

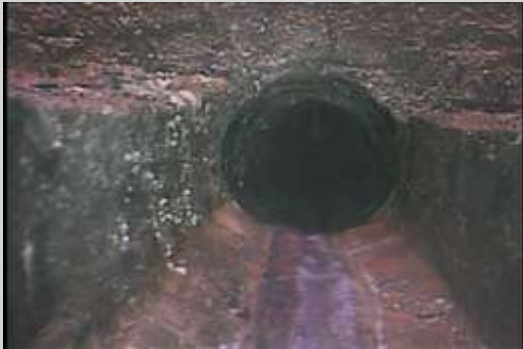
12 O'Clock Outflow

Pipe Height: **8.4** (in.) Rod and Bar (Angled)
Pipe Material: **Clay** ☐ Pipe Lined
Invert Depth: **8.12** (ft.) Flow Characteristics: **Slow**
Deposits: ☐ None ☐ Mud ☐ Sludge ☐ Debris ☒ **Grease**
Silt Depth: **1** (in.) Deposits Extent: **Light**
Infiltration: **None** Pipe Seal Cond: **Sound**

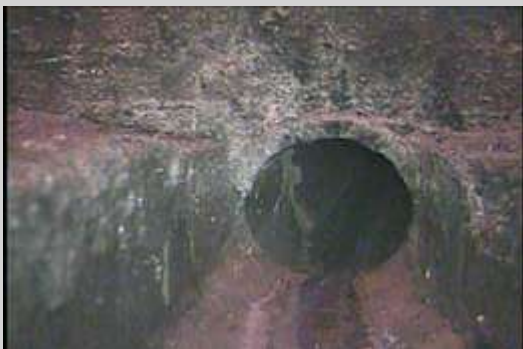
7 O'Clock Inflow

Pipe Height: **6** (in.) Rod and Bar (Angled)
Pipe Material: **Clay** ☐ Pipe Lined
Invert Depth: **7.94** (ft.) Flow Characteristics: **Slow**
Deposits: ☐ None ☐ Mud ☐ Sludge ☐ Debris ☒ **Grease**
Silt Depth: **1** (in.) Deposits Extent: **Light**
Infiltration: **None** Pipe Seal Cond: **Unknown**
